U.S. DEPARTMENT OF
ENERGY

Legacy
Management

2021 Annual Site Inspection and Monitoring Report for Uranium Mill Tailings Radiation Control Act Title I Disposal Sites

March 2022

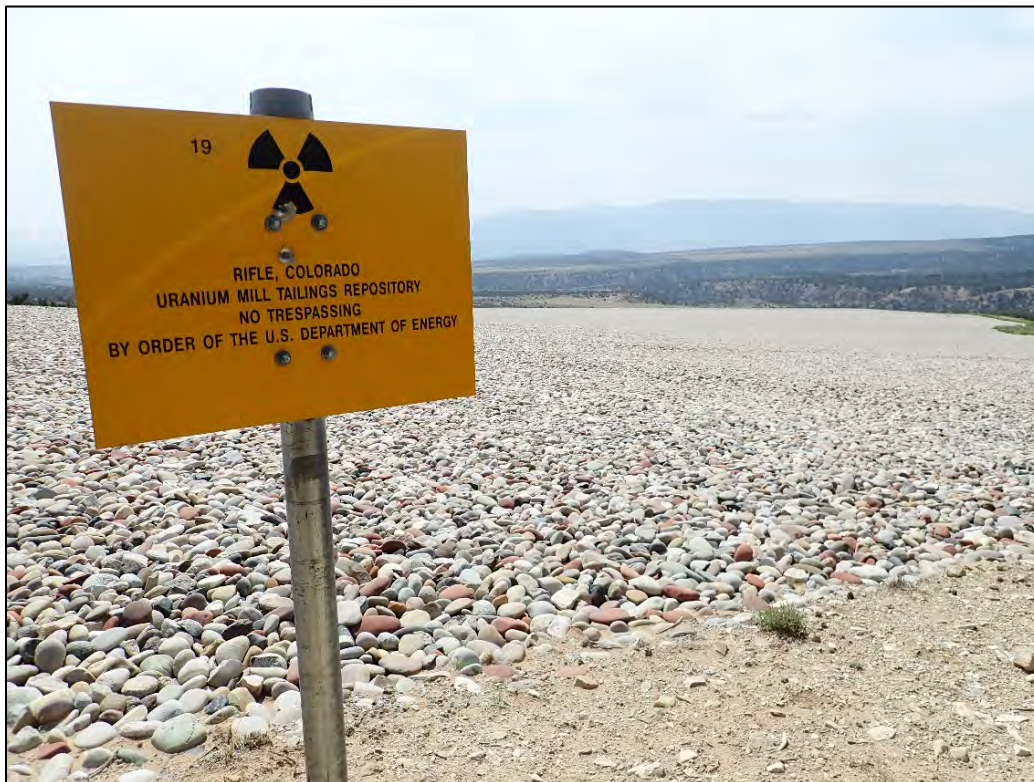
There are 27 perimeter signs positioned along the perimeter. Perimeter signs P0 through P11 are attached to the stock fence, and signs P12 through P26 are attached to steel posts set in concrete and set back 5 ft from the boundary (PL-2). Perimeter signs P15 and P19 have bullet damage, but remain legible and do not need to be replaced at this time. Perimeter sign P18 has shown minor cracks and peeling but remains legible. No other maintenance needs were identified.

PL-2. Perimeter Sign P19

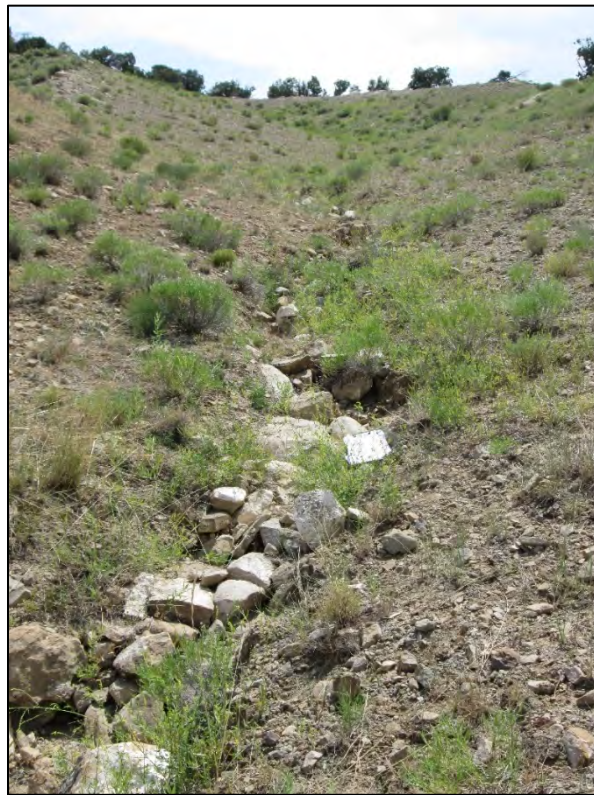
PL-7b. Gully Erosion in Interceptor Trench Outfall in 2016—Photo for Comparison

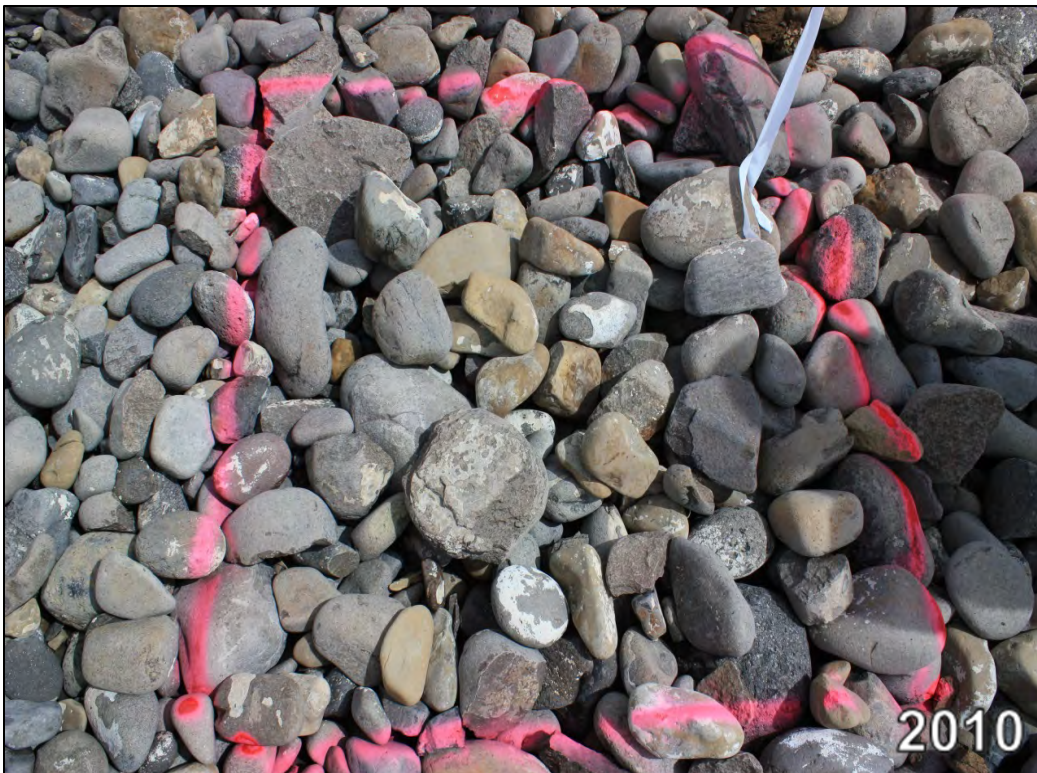
PL-5. (b) Rock Quality Plot No. I—2010 Photo for Comparison

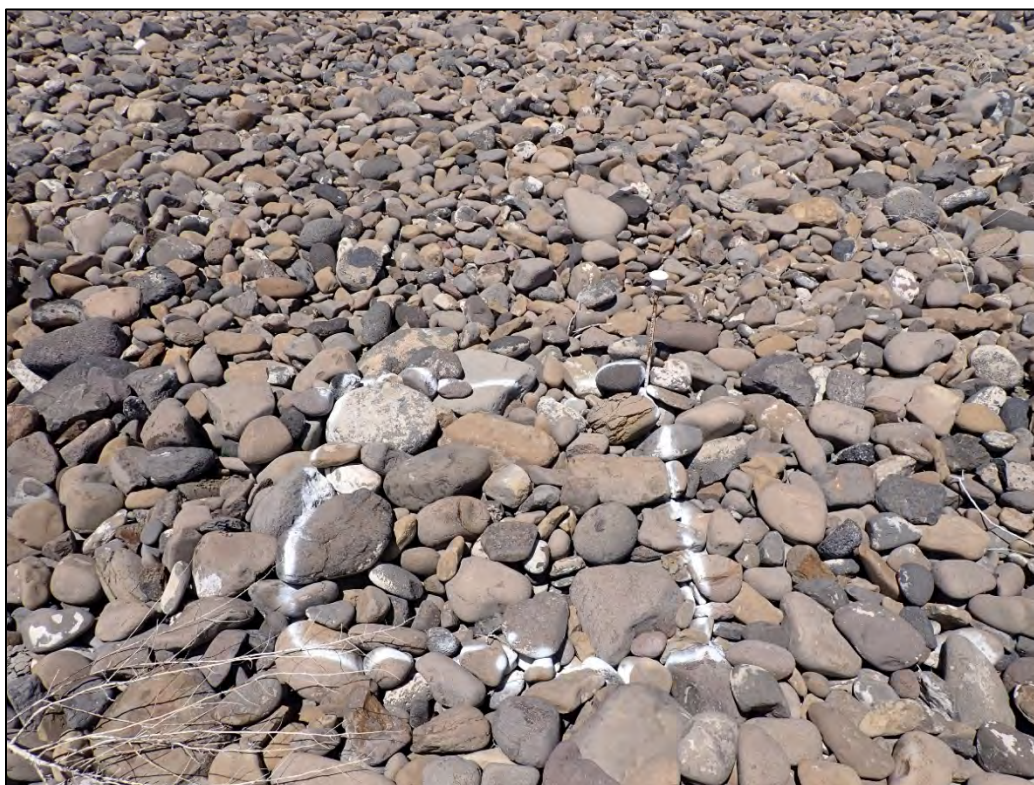
PL-6. (a) Rock Quality Plot No. II—2021

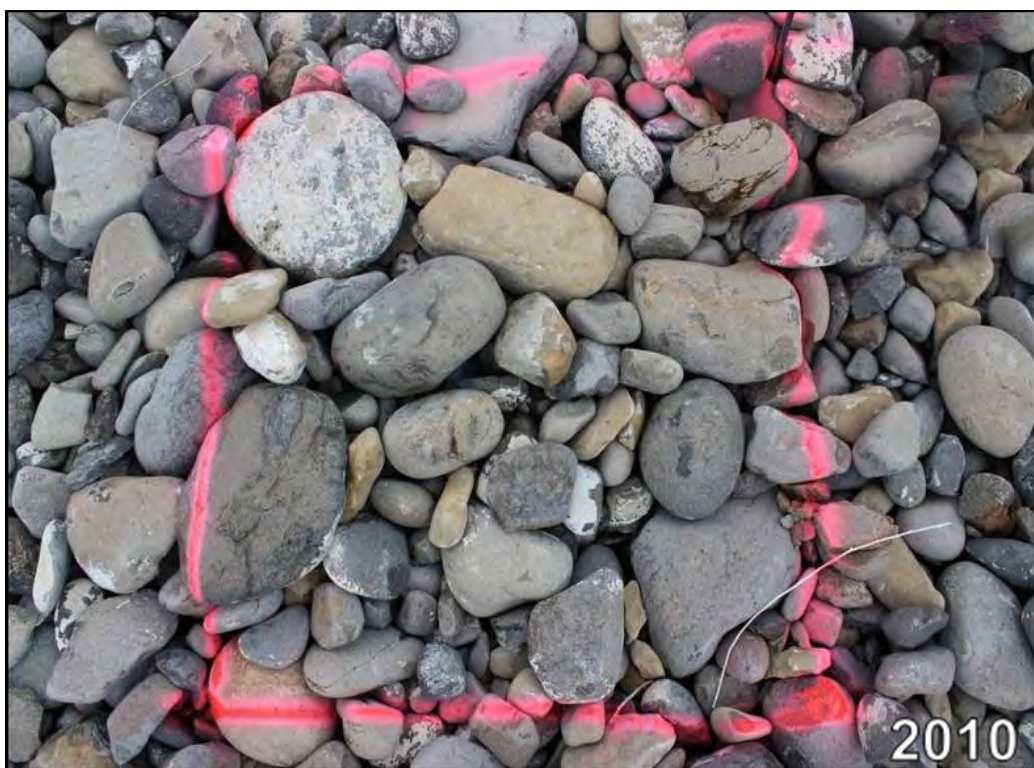
PL-6. (b) Rock Quality Plot No. II—2010 Photo for Comparison

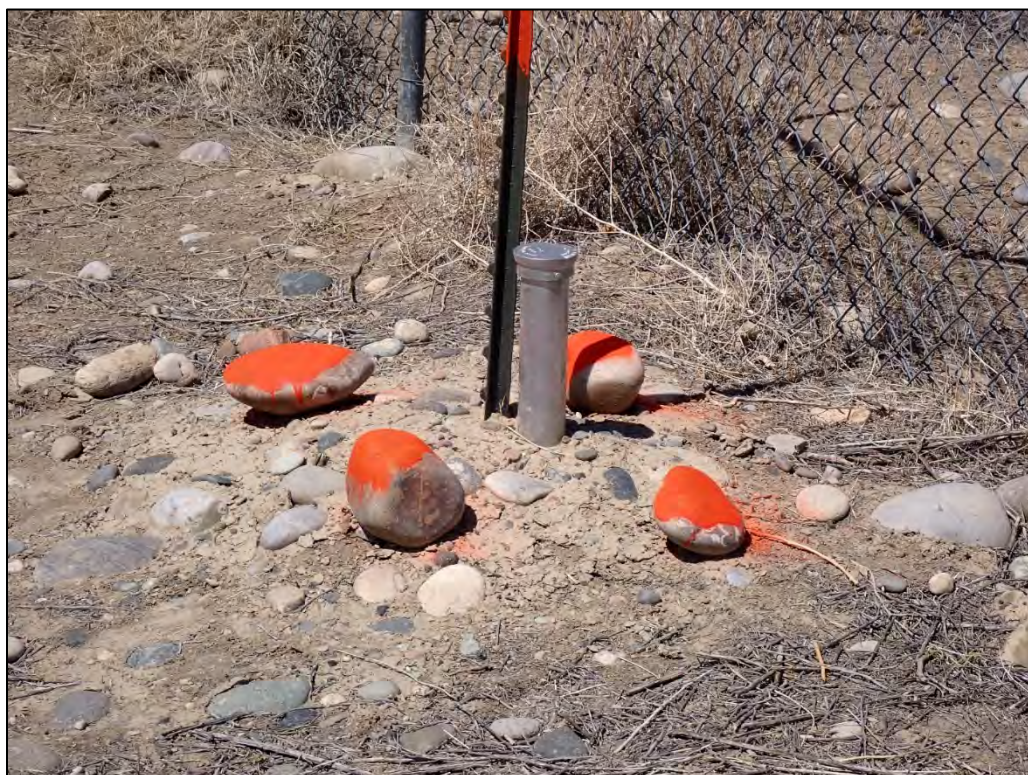
PL-3. Site Marker SMK-2 on Cell Top

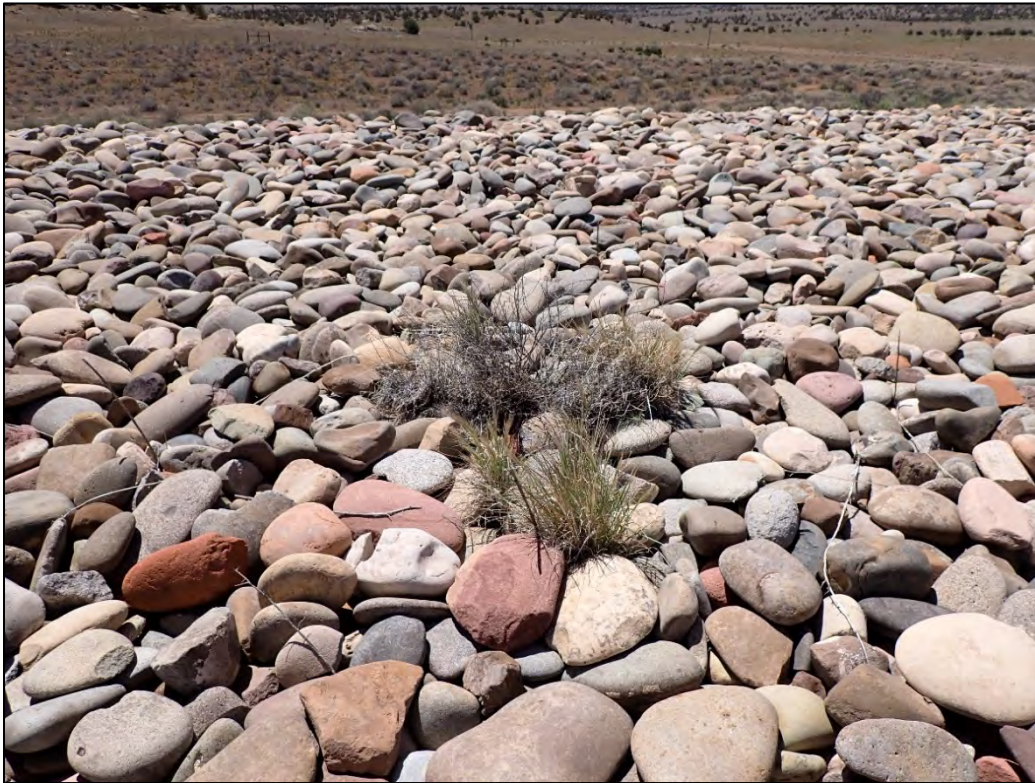
PL-6. Disposal Cell Cover

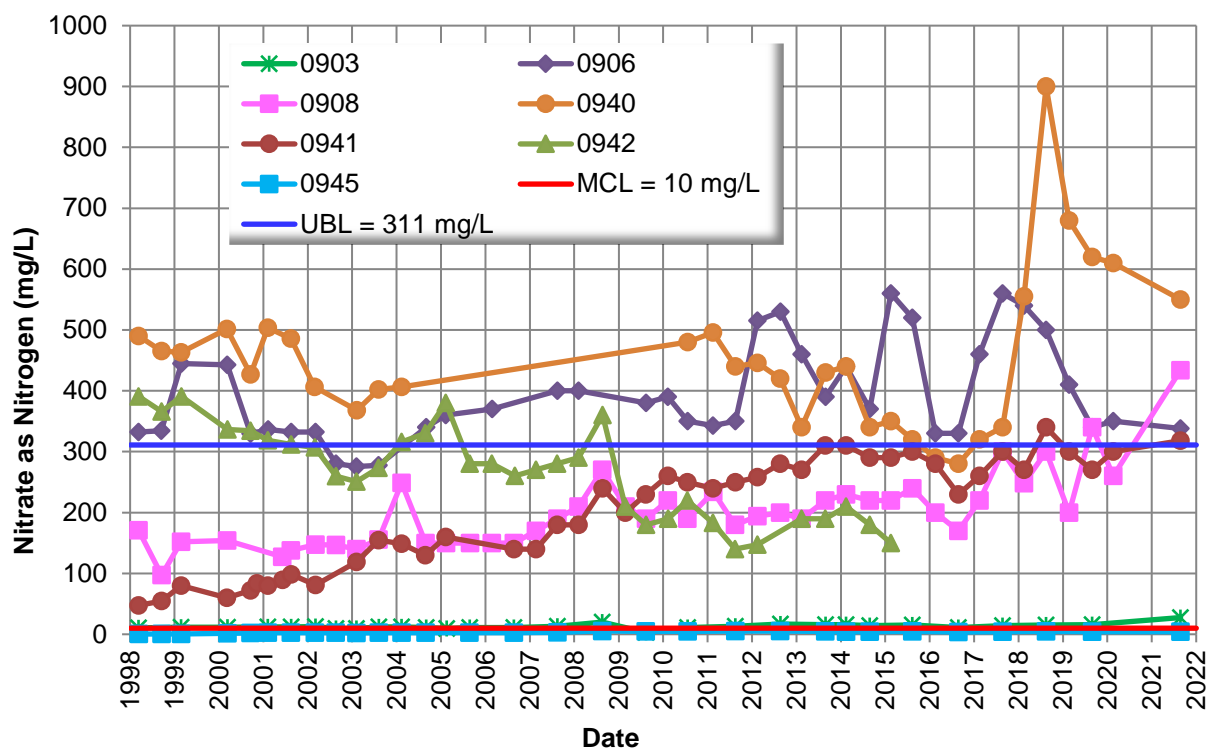
Figure 19-4. Nitrate in Groundwater at the Tuba City, Arizona, Disposal Site

Nitrate concentrations have historically exceeded the 10 mg/L MCL in all LTSP evaluative wells except background well 0945 (Figure 19-4). Exceedances of the 311 mg/L UBL were observed at compliance wells 0906 (338 mg/L), 0908 (434 mg/L), 0940 (550 mg/L), and 0941 (318 mg/L) in August 2021. Nitrate concentrations in distal downgradient well 0903 have regularly exceeded the MCL since 2004 but remained below the UBL in 2020.

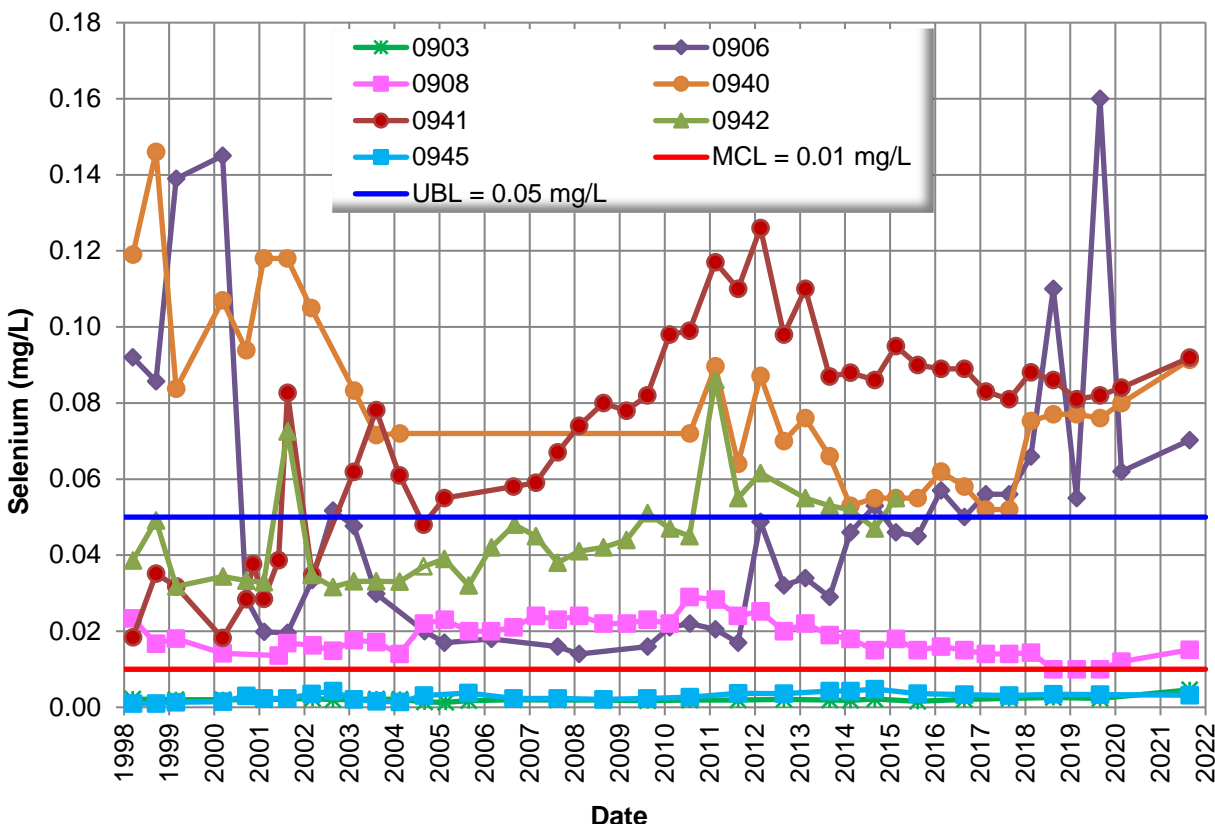
Figure 19-5. Selenium in Groundwater at the Tuba City, Arizona, Disposal Site

Selenium concentrations have historically exceeded the 0.01 mg/L MCL in all LTSP evaluative wells except background well 0945 and distal well 0903 (Figure 19-5). Concentrations in well 0908 exceeded the UBL for selenium in 1997 and have since remained at or slightly above the 0.01 mg/L MCL since August 2018. Selenium concentrations in well 0942 exceeded the UBL in February 2015, and that well has not been sampled since. Concentrations continued to exceed the 0.05 mg/L UBL in wells 0906, 0940, and 0941, all of which are immediately downgradient of the disposal cell. Selenium concentrations increased in well 0941 from 0.018 mg/L in 1998 to 0.09 mg/L in 2021. Selenium concentrations in distal downgradient well 0903 have consistently been below both the UBL and the MCL and, since late 2004, below levels measured in background well 0945.

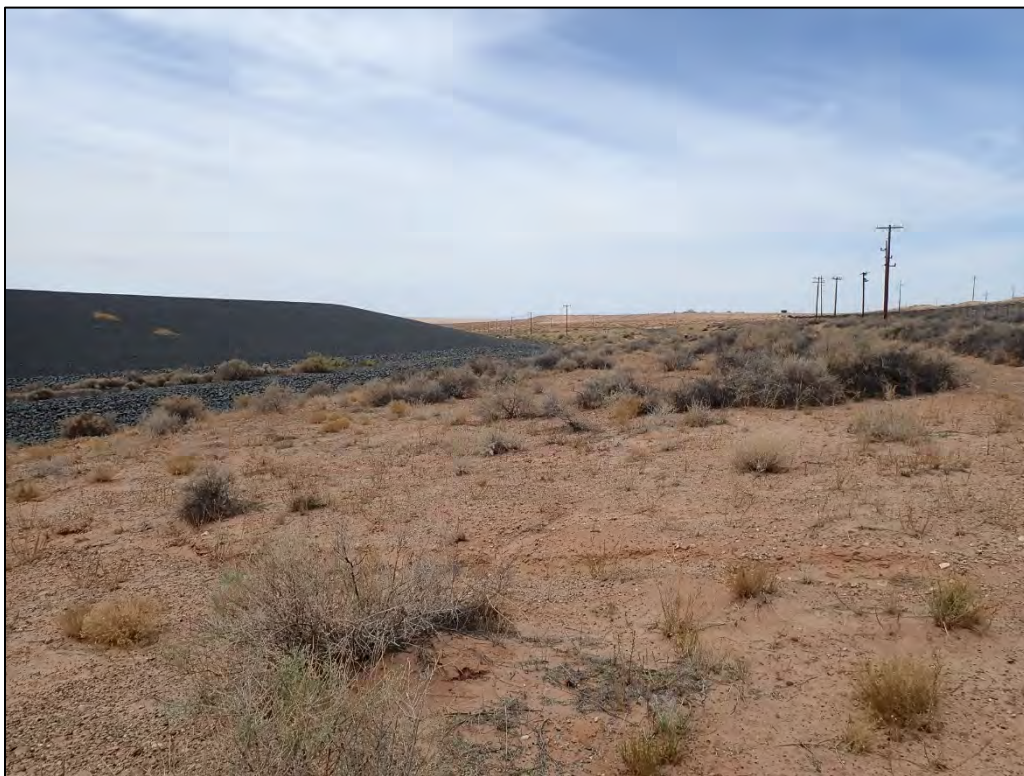
PL-11. Drought-Stricken Vegetation in Reclaimed Area

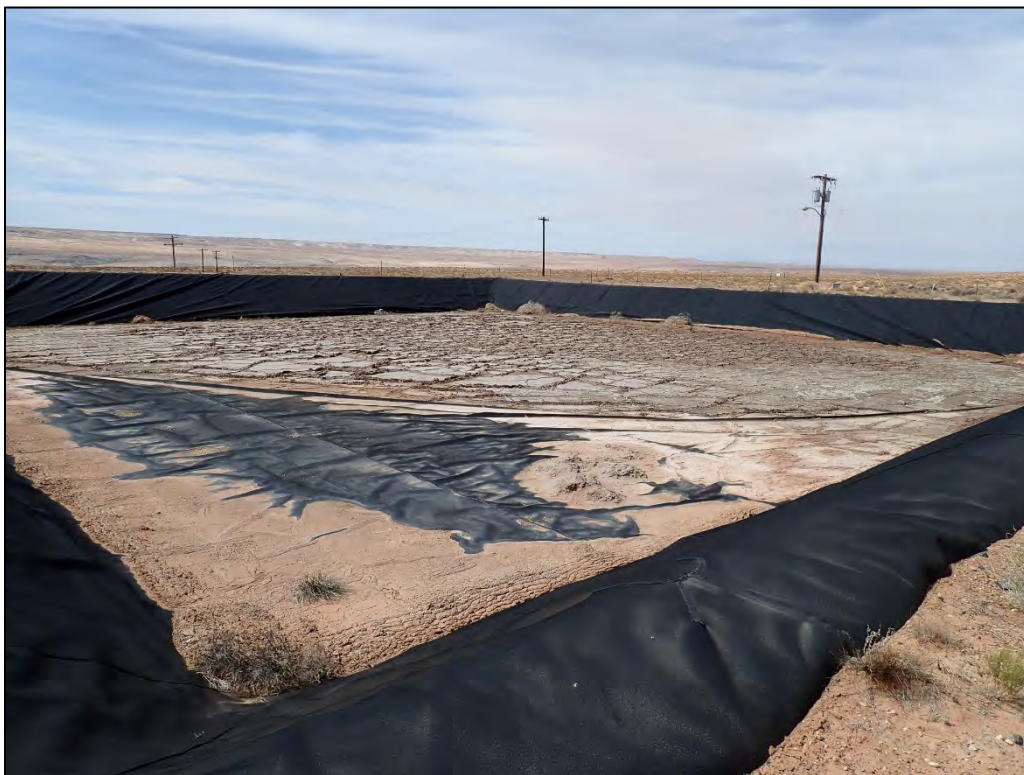
PL-12. Evaporites and Windblown Sand in Inactive Evaporation Pond
